NOTES ON COMMENTS MADE ON THE FACULTY APPLICATION TO RE-ORDER ST NICOLAS, GREAT BOOKHAM: OFS No: 2021-058069

- 1.1. This note sets out a detailed response on behalf of St Nicolas, Great Bookham to the points raised by DAC and others on the faculty application made to re-order the church in January 2021 – OFS No: 2021-058069

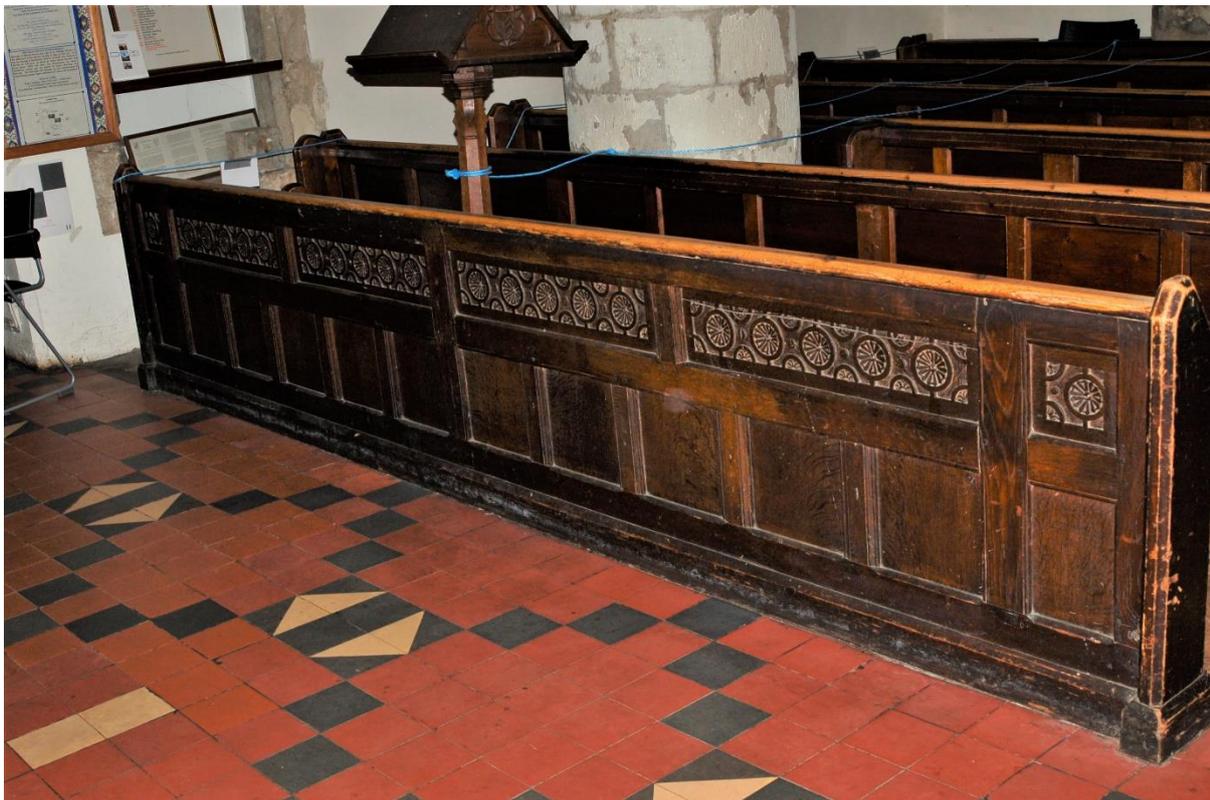
- 4.4. There are panels that are believed to be remnants of Georgian pews which Butterfield (we assume) has reused in the back of the bench immediately in front of the font and in the front of the pew behind the font, fronting on to the cross-aisle – see photo below. The panels in the back of the pew in front of the font are partially obscured by the font. These panels (nine in total) probably date from the 17th or 18th century and are arguably of greater interest than the Victorian pews. However, they do not represent a coherent scheme and appear just to have been reused. The intention is to reuse these fragments in a coherent way, ensuring they are presented better. A number of options are under consideration.
